# KUDRNA & ASSOCIATES, LTD.

Re: Illinois International Port District/  
Metropolitan Water Reclamation District  
103rd and Doty Landfill Closure  
Golf Course Development

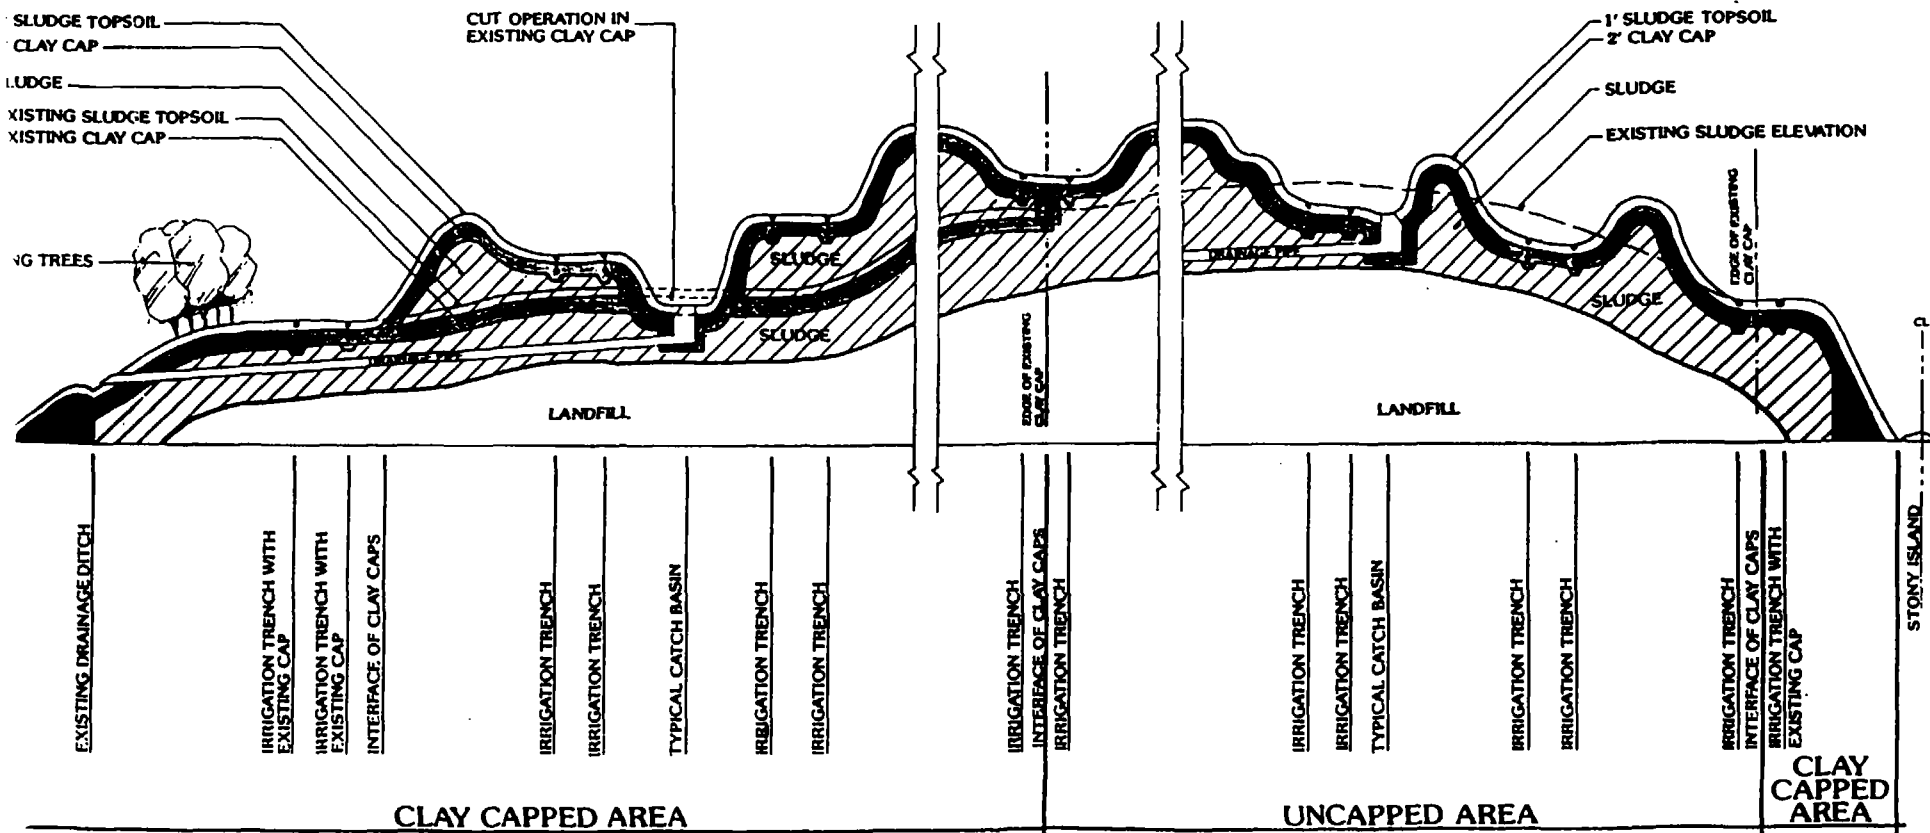
## SITE SECTION

OUTLINE OF MATERIAL TO BE  
EXCAVATED AND REPLACED  
AS SPECIFIED

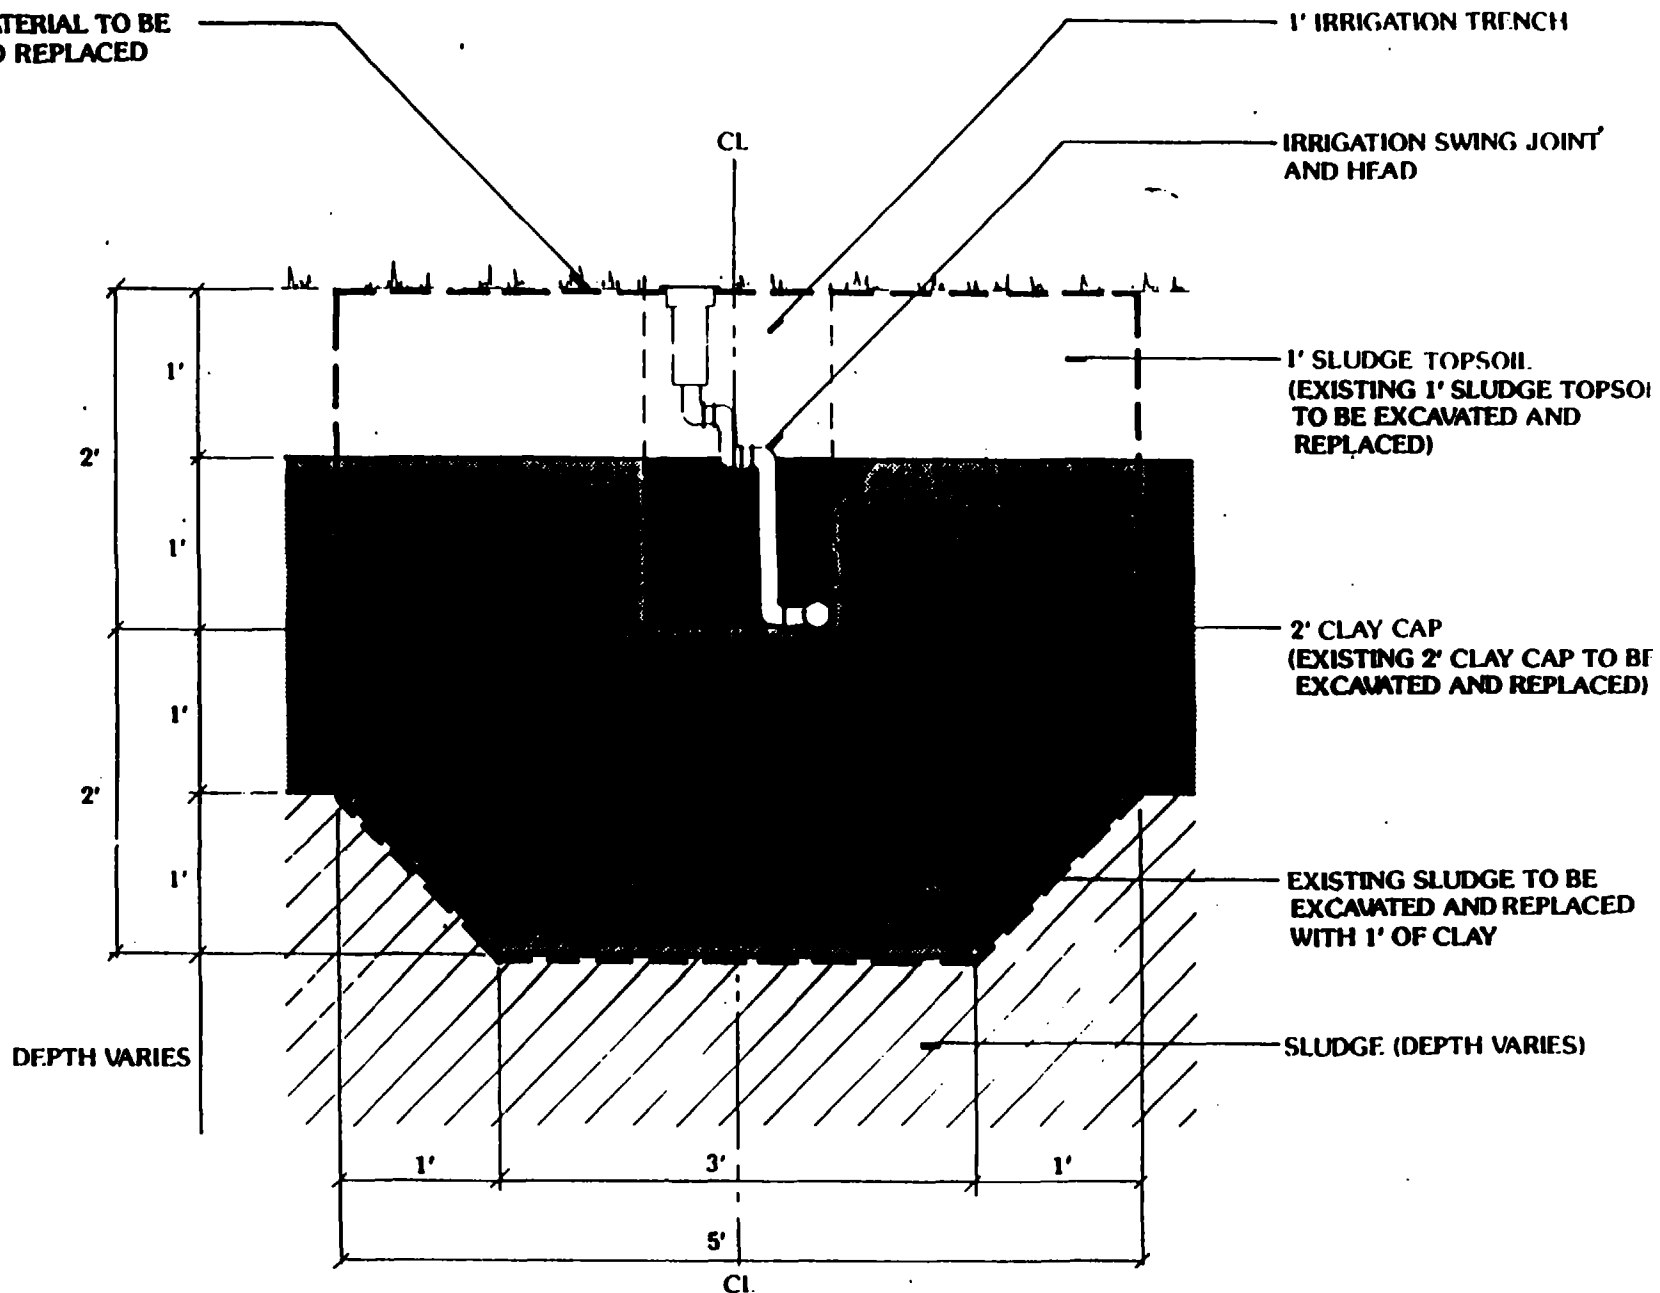
## IRRIGATION TRENCH WITHIN EXISTING CLAY CAP DETAIL

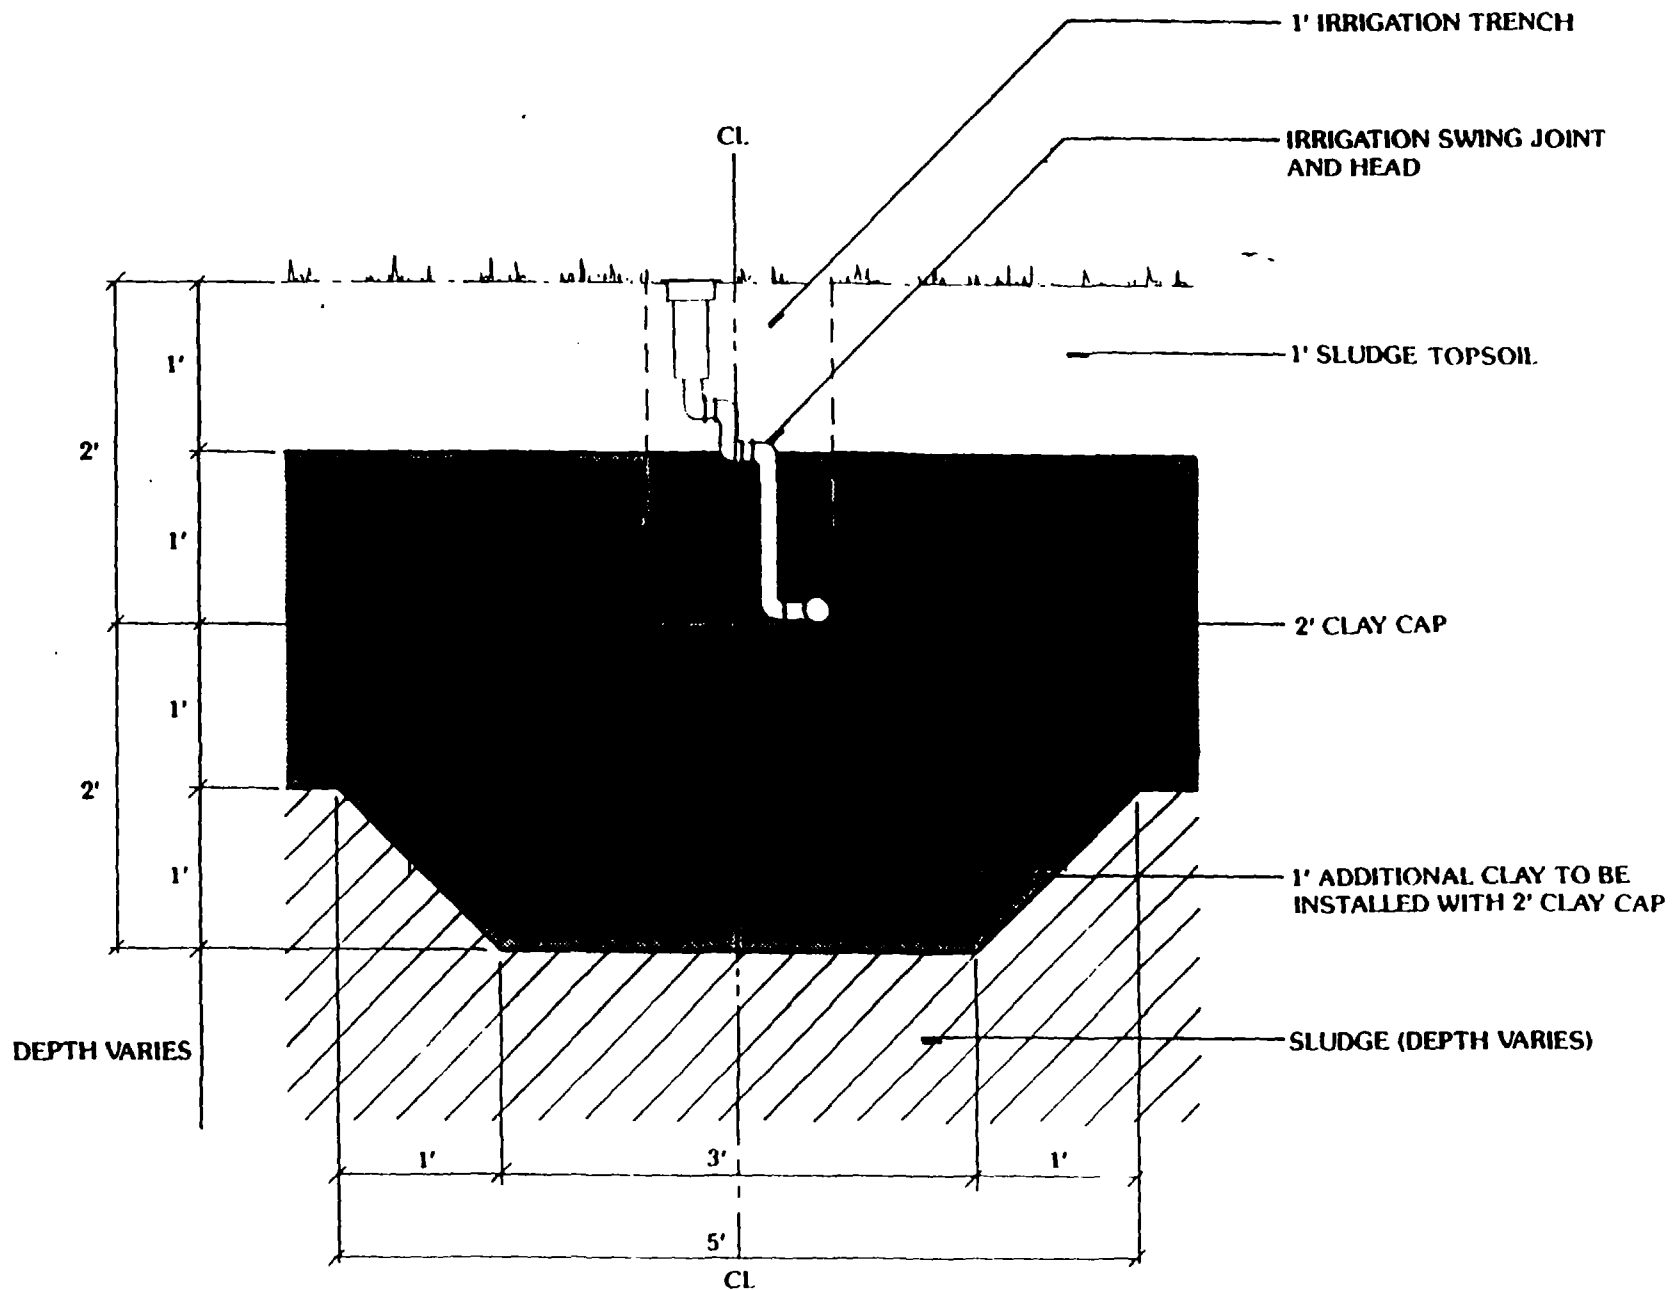
EX 11 C

## IRRIGATION TRENCH WITHIN NEW CLAY CAP

Similar to the closed areas, in unclosed areas a two-foot clay cap will be constructed totally around any irrigation line. This is shown on Exhibit 5, attached.

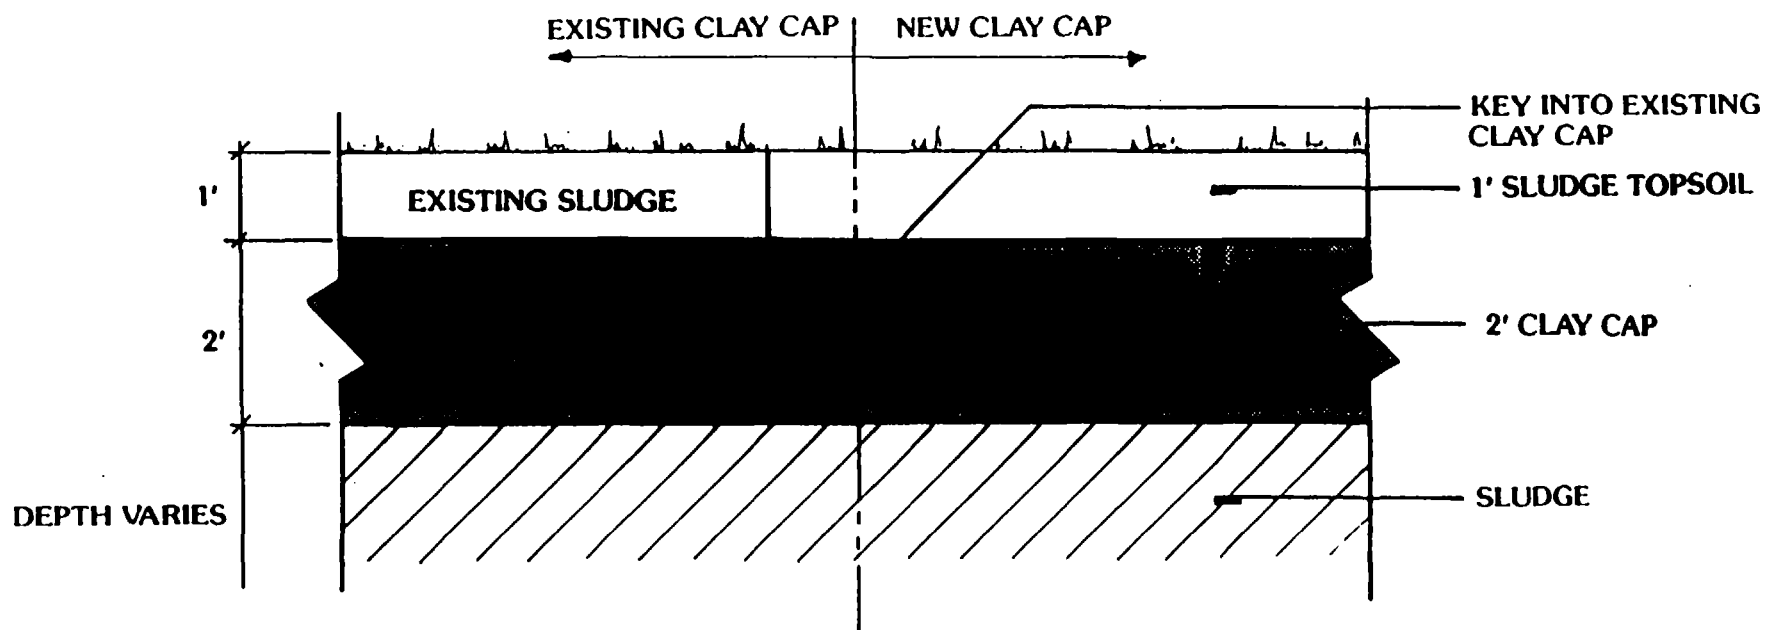
EXH. 6

## INTERFACE WITH EXISTING CLAY CAP

The keying in of the clay cap is shown on the attached Exhibit 6. This is a conceptual detail, however, it is our intent to adapt this detail to all areas of the site where we must connect to the existing cap. This should eliminate the possibility of leakage through the clay cap.

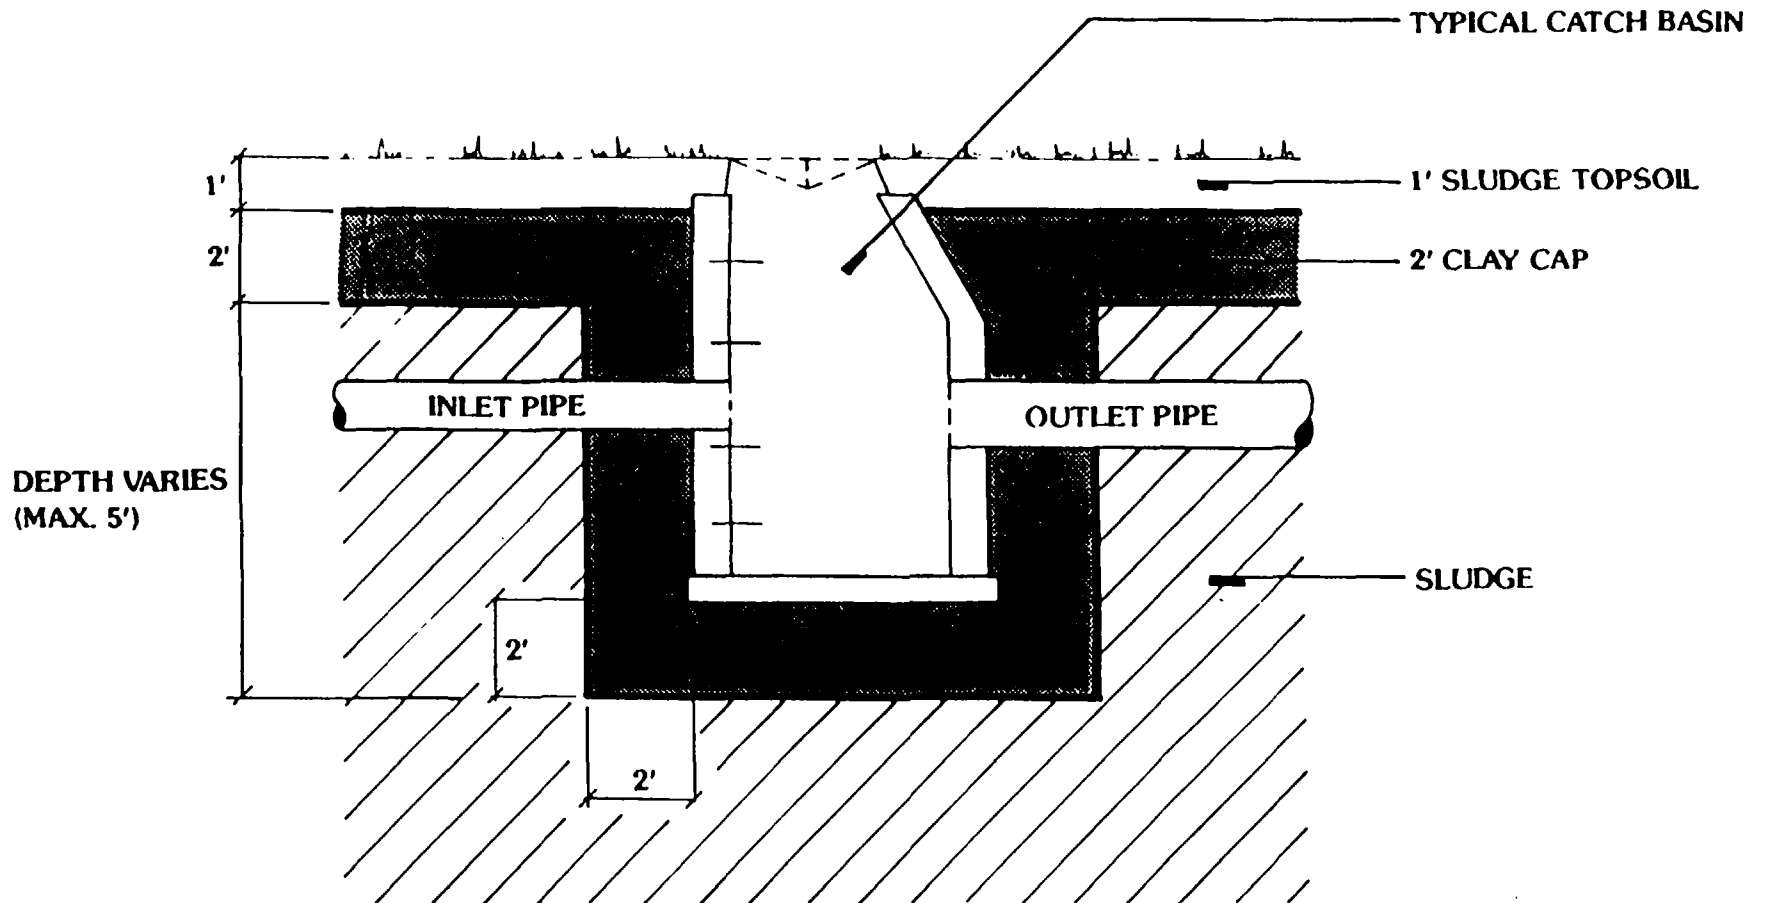
**TYPICAL CATCH BASIN DETAIL**

- 5) A similar situation will affect the construction of the storm water drainage pipes. We propose that where the greatest potential exists for leakage (at the catch basin or manholes) that the entire structure be sealed with the clay cap. The detail for

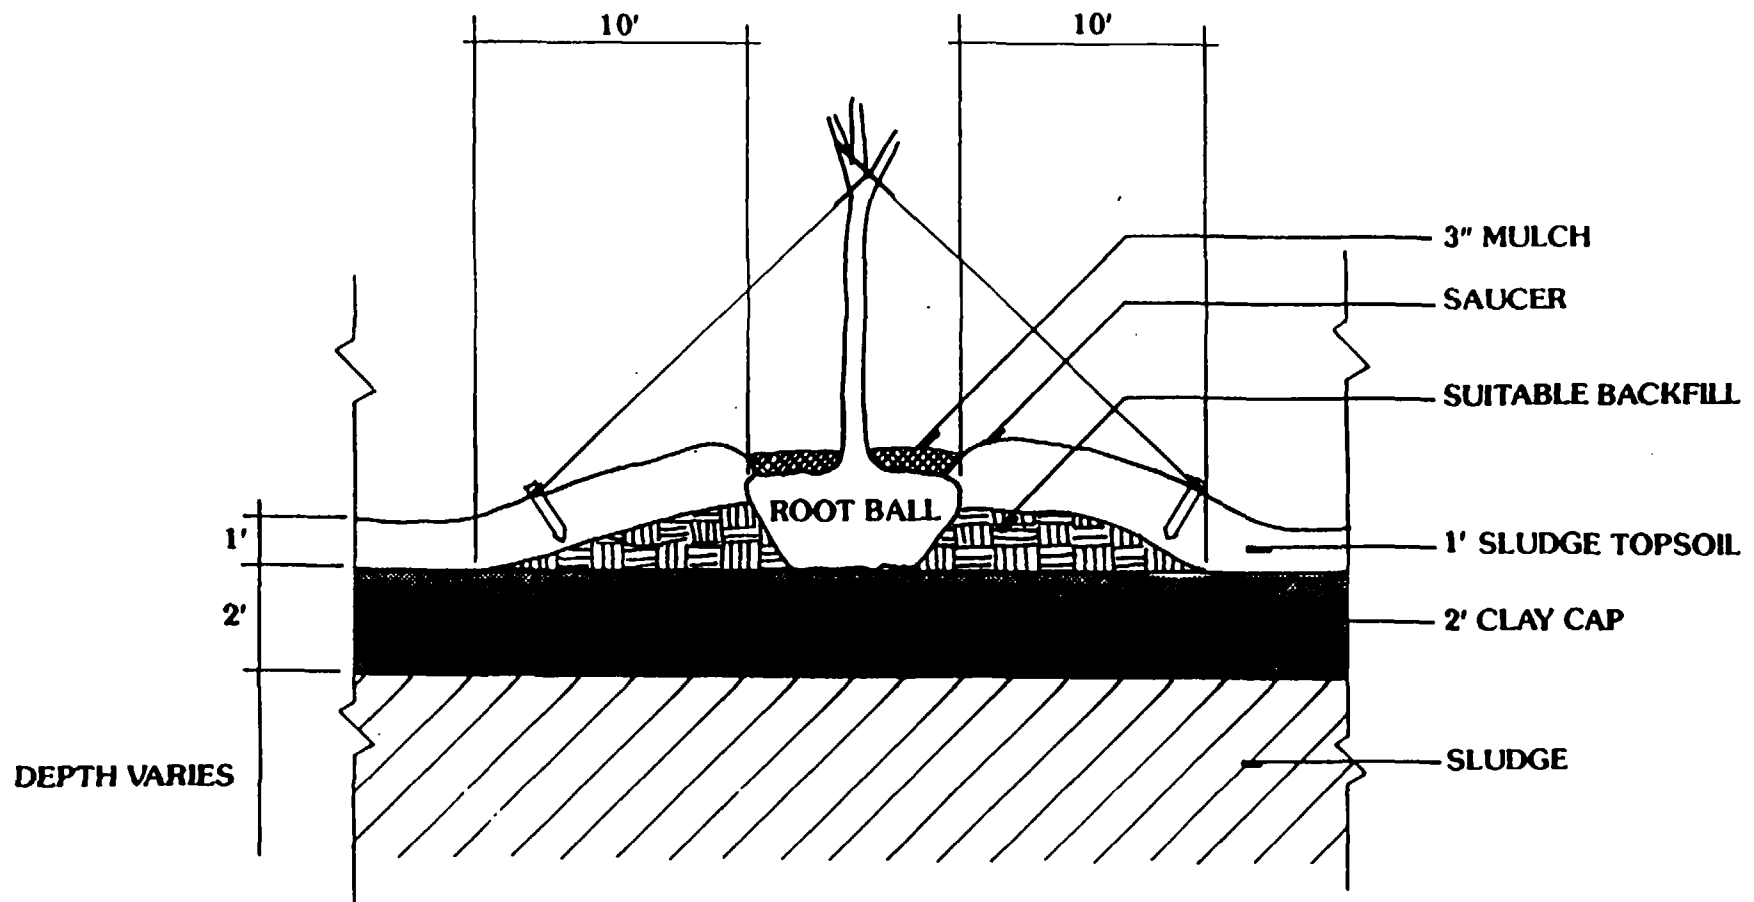
**TYPICAL TREE DETAIL**
